ARTFUL DODGERS AT PEACH BOTTOM

In January 2010, workers at the Peach Bottom nuclear plant in Pennsylvania tested control rods in the Unit 2 reactor to see how long it took to rapidly insert, or scram, them into the core. The test results were slow, slow, and slow:

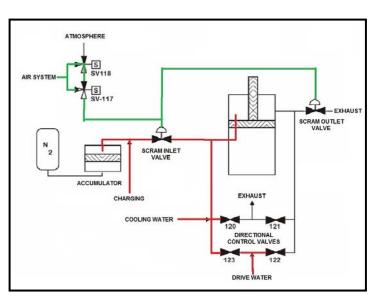
A control rod is moved using a hydraulic piston depicted by the cross-hatched inverted T inside the large rectangle in the figure. The rectangle represents the cylinder housing the piston, and the vertical part of the inverted T is connected to the control rod, which is above the piston. The piston is attached to the bottom of the reactor pressure vessel that houses the reactor core.

Three of the 19 control rods failed to reach notch 46 within 0.44 seconds, but met all other time limits. The test results showed that these control rods were slow to get moving, but moved fine once in motion. This clue led workers to discover the reason for the slow initial motion: parts within the solenoid valves (labeled SV-117 and SV118) had degraded and were partially blocking the vent pathway for the air supply to the scram inlet and outlet valves. As a result, it took longer for the air pressure to drop down below the point where spring forces would open the scram inlet and outlet valves. Once these valves did open, the control rods scrammed normally.

The solenoid valve degradation problems had been identified in the mid-1990s. The vendor developed a part less vulnerable to degradation and had offered free replacements in 1997 under its warranty program. For some reason, Peach Bottom's owner did not take advantage of the free safety upgrades and continued to operate with parts it had installed in 1995—despite knowing they were susceptible to degradation damage. Compounding that error, workers at Peach Bottom also failed to track the scram test results for individual control rods, which is commonly done at other nuclear plants. This information permits reactor operators to make informed decisions about replacement and repairs of control rod components. After the fact, workers at Peach Bottom reviewed the scram time results for the 21 slow control rods and saw clear warning signs of the pending failures.
